An Investigation Of The Causes And Recommendations For
Correction Of The Pinole Slipout, Road 04-CC-80

June 1969

AN INVESTIGATION OF THE CAUSES
and
RECOMMENDATIONS FOR CORRECTION
of the
PINOLE SLIPOUT
ROAD 04-CC-80

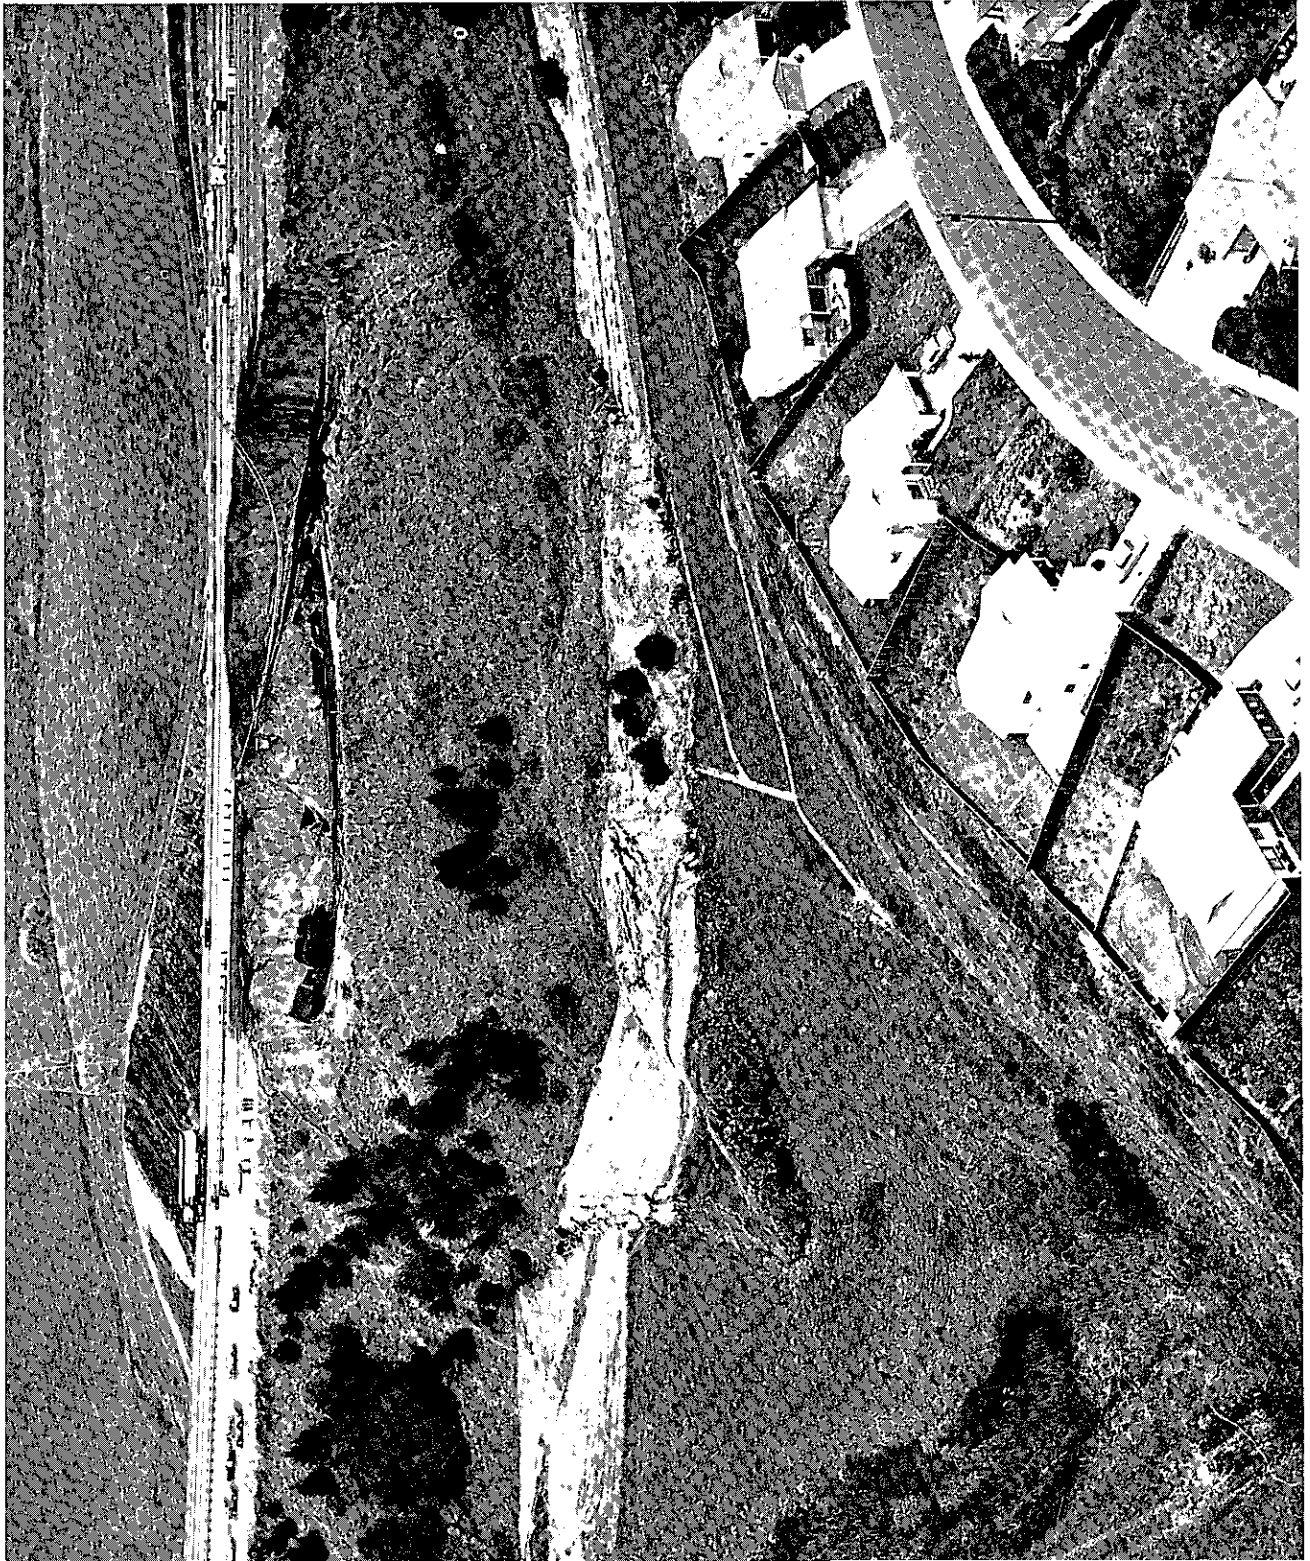
Figure 1

subdivision. The Pinole Fire Department responded immediately and applied chemical foam as a precaution against possible fire. Minor sloughing on the west escarpment face of the slide continued after the major movement took place on Sunday, May 11, to a point where, in the interest of public safety, it was best not to route traffic adjacent to the slide area. The single northbound lane was closed at 9:45 AM on Wednesday, May 14, thereby completely closing all six lanes in both directions to traffic. An overall view of the slide is presented by Figure 1.

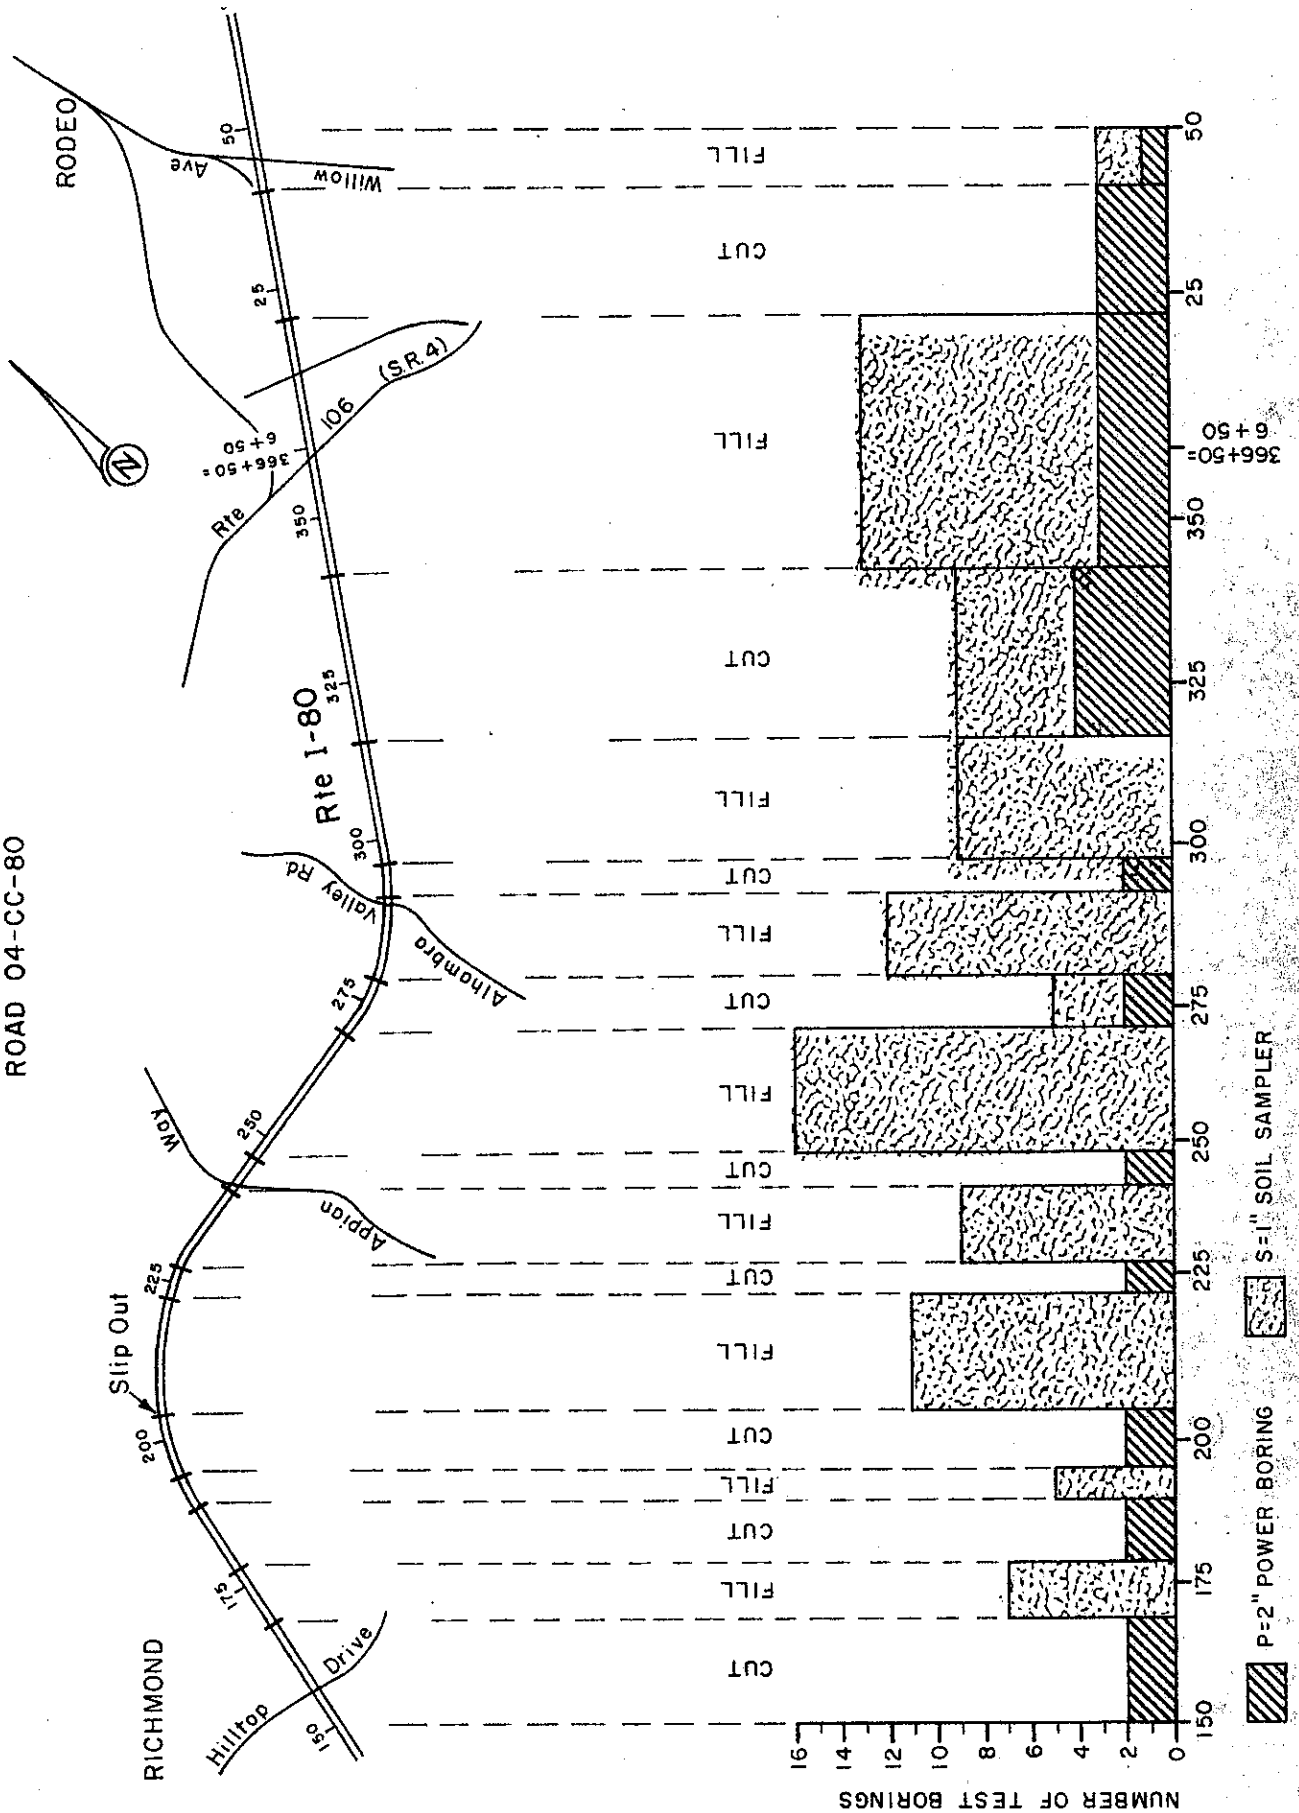
Figure 2

A comparison of the exploration effort for the various cut and fill areas on the project is shown in Figure 2. Here, power borings and 1" soil probe borings are differentiated.

Power borings, as shown by Figure 2, were generally made only in proposed cut areas. However, in two proposed fill areas, (Station 346 - 19+75 and 30+50 - 45+) where a lush growth of grass made moisture conditions suspect, power borings were made. These borings revealed the existence of compressible soils underlain in some areas by soils of lower strength. Because of this, these two fill areas were further explored with 12 two-inch sample borings at the start of construction. At this time, instrumentation was installed to monitor settlement and pore water pressure during construction of the fills.

COMPARATIVE PRELIMINARY FOUNDATION INVESTIGATION

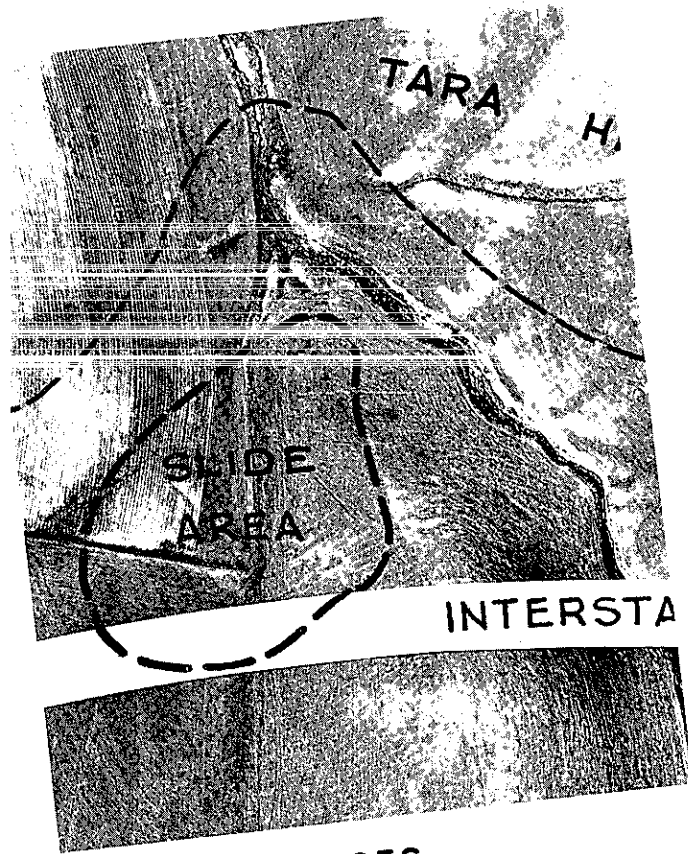
1956

AERIAL VIEWS OF SLIDE AREA (1956-1969)

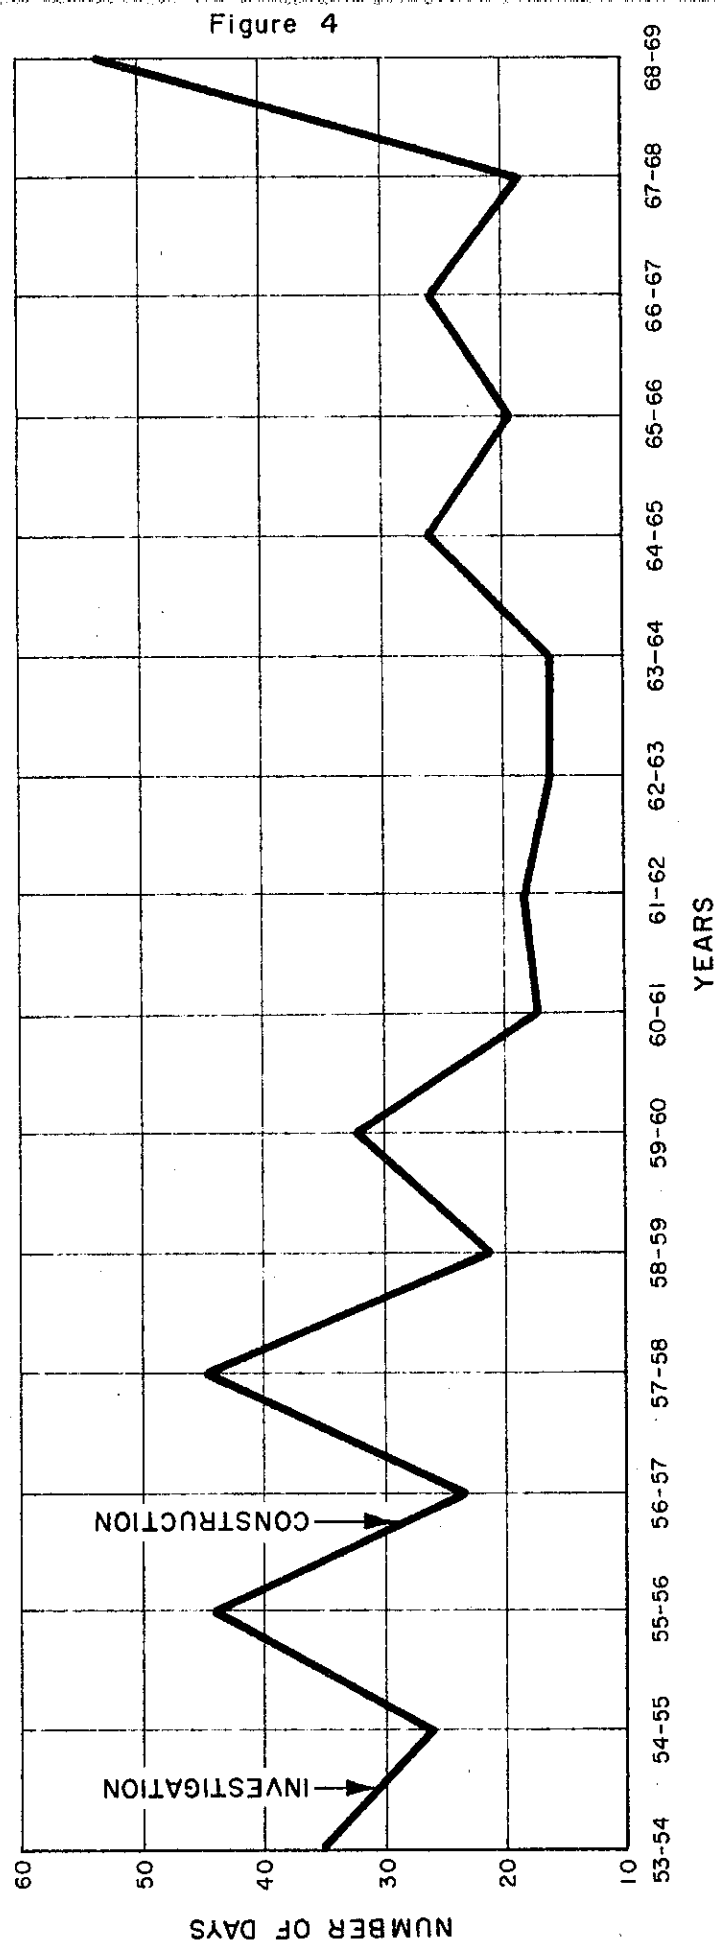
Figure 4 presents a plot of number of rain days (1/10 inch or more per day) during the six month winter period of October through March vs. year since 1953. It is believed that number of rain days which occur during the winter season is probably a better indicator of infiltration of precipitation than total precipitation for a given period, since, very frequently, relatively

TOTAL NUMBER OF DAYS WITH
RAINFALL EXCEEDING 0.10 INCH
OCTOBER TO MARCH 1953-1969
Richmond, Calif.

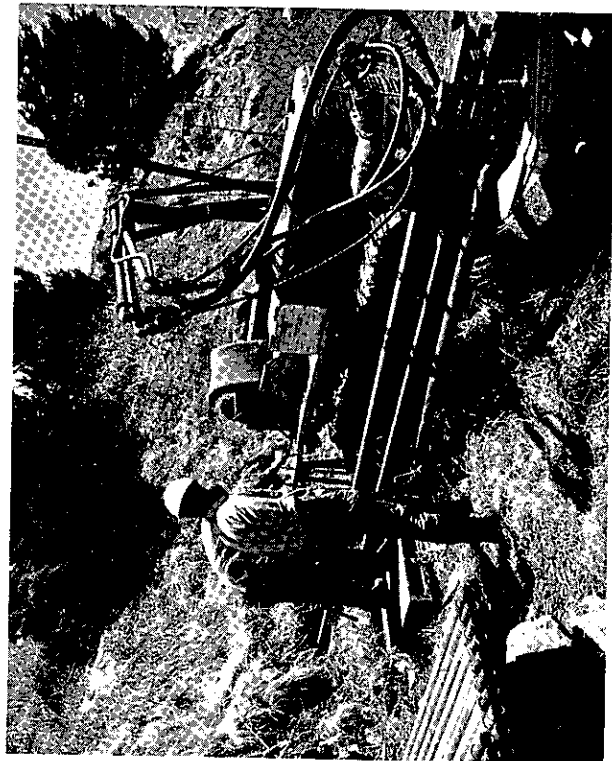
Horizontal Drain Installation

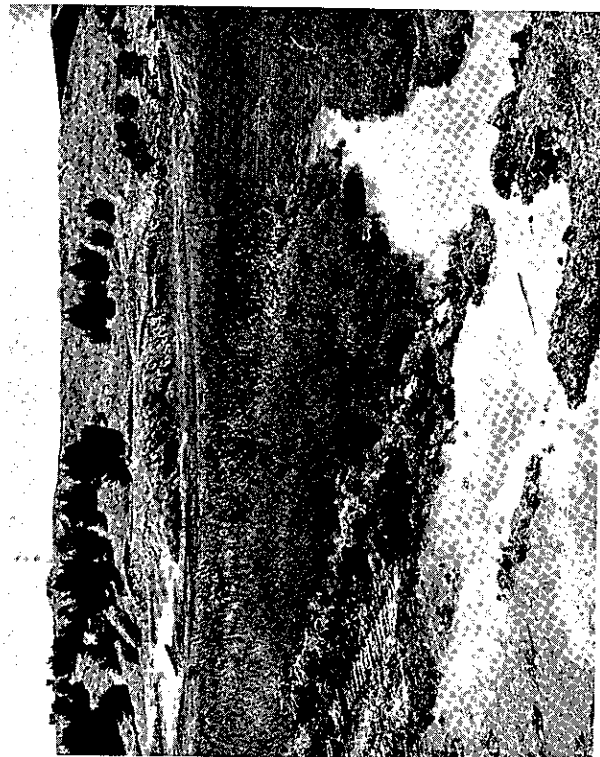
Free Water at Slide Toe

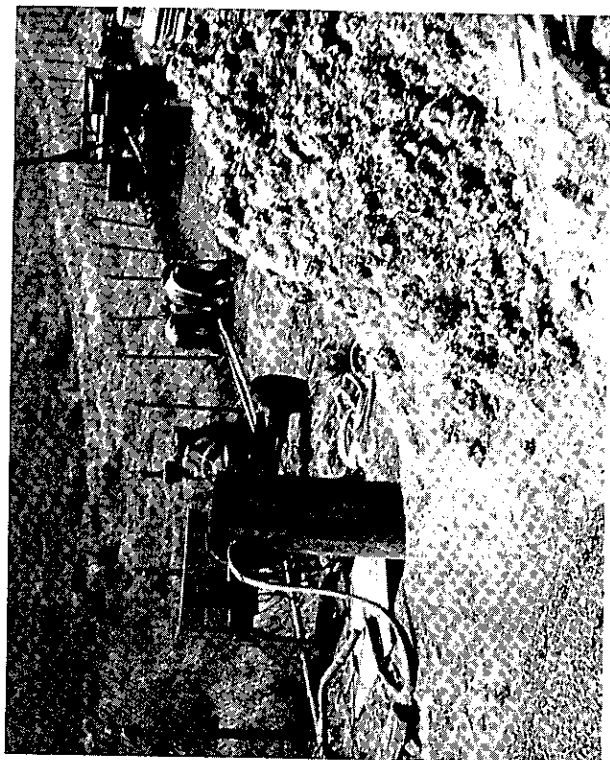
Pumping from cased 3' Dia. Auger Holes

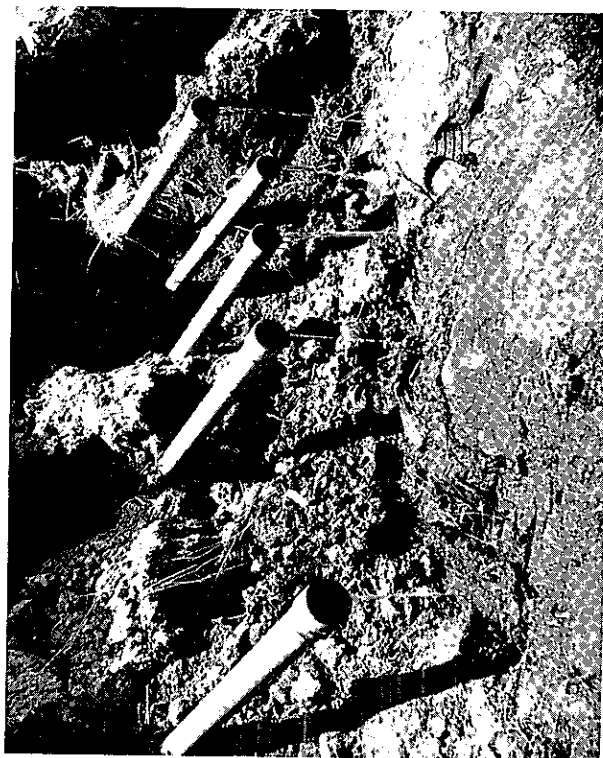
Horizontal Drains
